# **General Aviation Airworthiness Alerts**

**AC No. 43-16**

**ALERT NO. 225  
APRIL 1997**

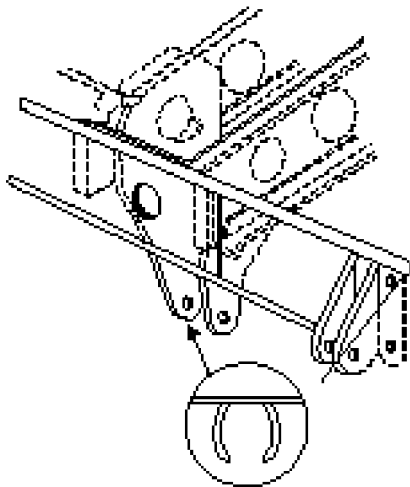
An investigation of the stabilator control system disclosed the stabilator actuator attachment brackets ("lever P/N's TB10.34.006.103 and .104") were bent in a "bowed out" position. (Refer to the following illustration.) This condition effectively changed (shortened) the travel of the stabilator. The submitter speculated this damage was caused by wind gusts on the tail section of the aircraft with the flight control lock installed. It is possible this damage was caused by exhaust blast from the engine of a larger aircraft. This is a good reason to separate large aircraft from small aircraft on the parking ramp. Also, this defect may have

been discovered during a thorough preflight inspection, avoiding jeopardy of the aircraft and occupants during flight.

Part total time-956 hours.

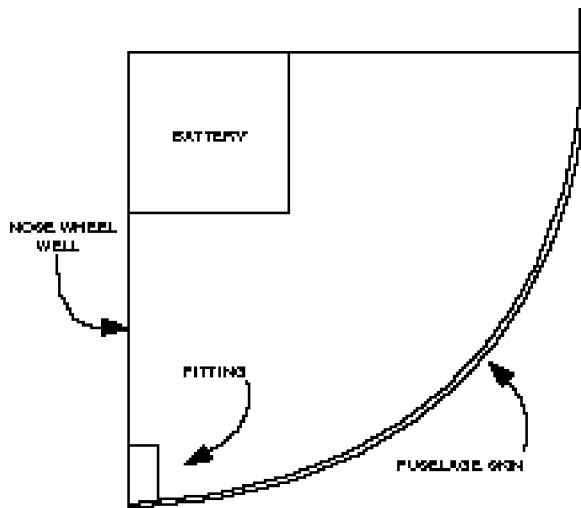
<b>Beech Fitting Model B58 Baron</b>	<b>Nose Landing Gear Damage 3221</b>
--	--

The nose landing gear drag link hinge point fitting (P/N 35-400304-3) was found severely corroded and cracked during a scheduled inspection.

The fitting was corroded at the lower attachment bolt hole which was elongated and cracked. Also, the bolt was loose. The submitter speculated this damage was caused by water and condensing vapor and/or liquid discharged from the battery being trapped in this area. (Refer to the following illustration.) This damage rendered the fitting to a state of imminent failure. It is recommended this area be thoroughly inspected at every opportunity. Cleaning and corrosion treatment may be helpful in preventing reoccurrence of this defect.

Part total time-6,000 hours.

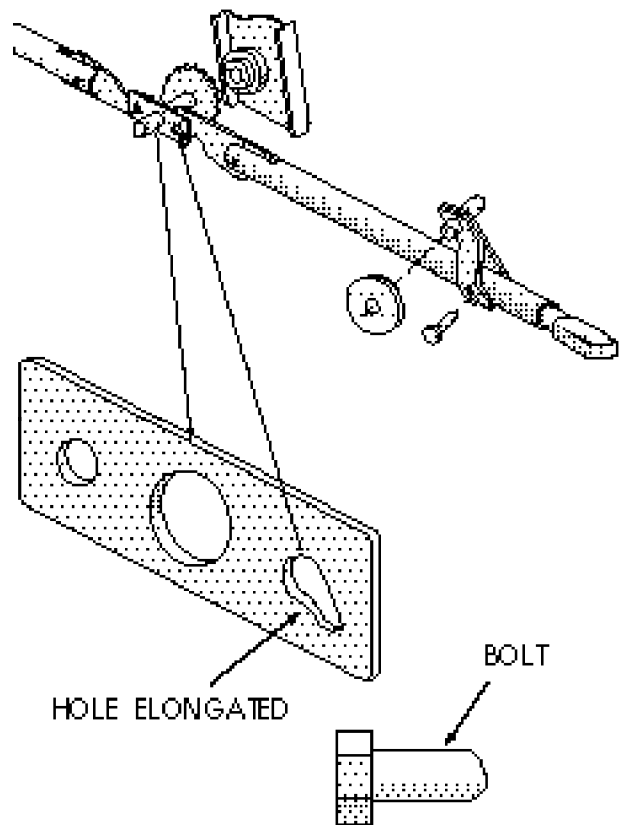
It appeared the upper forward hook and rod link were not moving when the handle was turned. After 3 hours of trying to get the door open, a decision was made to cut the right aft cabin window to gain access to the emergency exit release handle. Entry was gained through the emergency exit, and the cabin door panels were removed. The upper "braze assembly" (P/N 50-430043-1207) attachment hole for the upper door latch link was found severely elongated, and the bolt had broken. (Refer to the following illustration.) It was suggested

the door panels be removed during scheduled inspections to allow inspection and lubrication of the mechanism.

Part total time-4,900 hours.

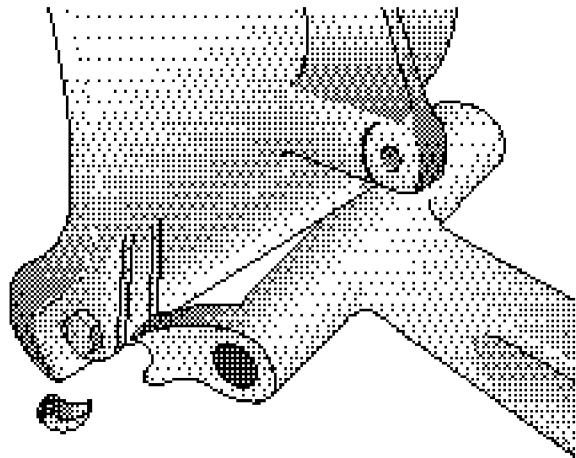
**Broken Rudder  
Pedal  
2720**

It was reported to maintenance that the pilot's side right rudder pedal was broken.

The rudder pedal arm assembly (P/N 50-524326-10) was found broken at the attachment for the rudder pedal assembly (P/N 50-524402-613) during an inspection.

(Refer to the following illustration.) All other rudder pedal attachments were inspected and found to be serviceable. The submitter speculated the bushing installed in the rudder arm assembly worked its way through the arm until the attachment hinge point failed.

Part total time-4,020 hours.

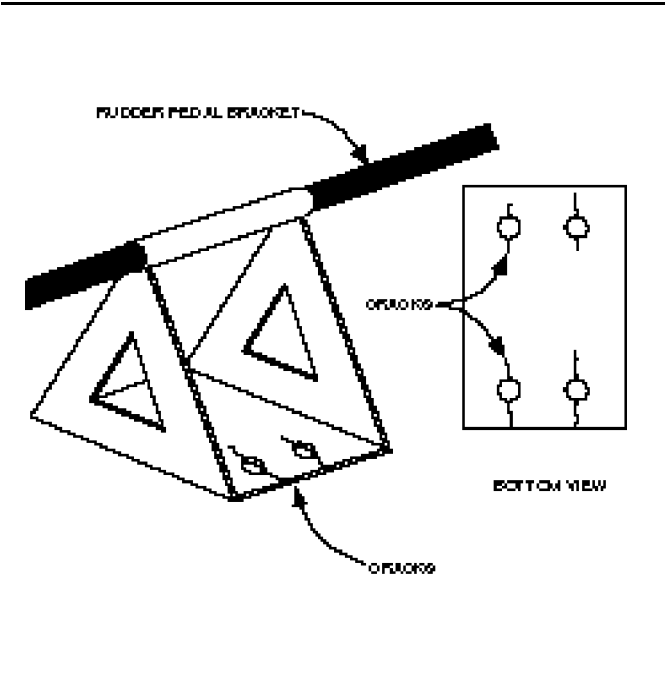
<b>Piper</b>	<b>Rudder Pedal Bar</b>
<b>Model PA 28-180</b>	<b>Support Cracks</b>
<b>Cherokee</b>	<b>5345</b>

The center rudder bar support bracket was found cracked during an annual inspection.

The support bracket (P/N 63451-000) was cracked at each of the four bolt attachment points. (Refer to the following illustration.) The submitter speculated this damage was caused by the nose wheel shimmying and/or the design of the bracket. It was recommended that all of the rudder bar support brackets be thoroughly inspected during scheduled inspections.

Part total time-3,800 hours.

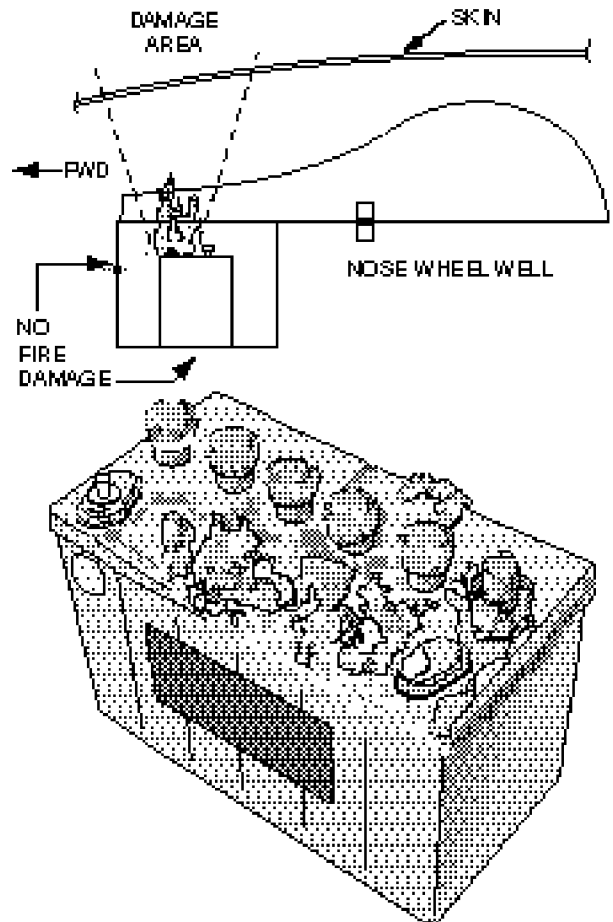
The pilot reported that during flight, he smelled smoke and saw a small amount of smoke in the cockpit for a brief time. No cause could be determined at the time, and all electrical systems were functioning normally. The pilot noticed after landing that the paint on the top of the nose section was scorched and "bubbled."

The nose baggage compartment was opened and soot was found covering the entire area as well as the nose wheel well. The battery cover was severely burned. The battery cover was then removed. It appeared the battery had "melted down," and a large section of the top case was burned away. (Refer to the following illustration.) Even with the top of the battery open, there was still electrolyte in the battery cells. This was a Gill, Model G-35 battery.

An investigation of the aircraft electrical system did not produce a reasonable cause for this failure. The submitter speculated the battery failed internally due to a "short" near the positive terminal.

Part total time-213 hours.
